# FINAL REPORT TO CONGRESS

THE STREAMBANK EROSION CONTROL  
EVALUATION AND DEMONSTRATION ACT OF 1974  
SECTION 32, PUBLIC LAW 93-251

REPORT EXCERPTS - NEW ENGLAND DIVISION PROJECTS

CONNECTICUT RIVER AT HAVERHILL, NEW HAMPSHIRE  
DEMONSTRATION PROJECT PERFORMANCE REPORT

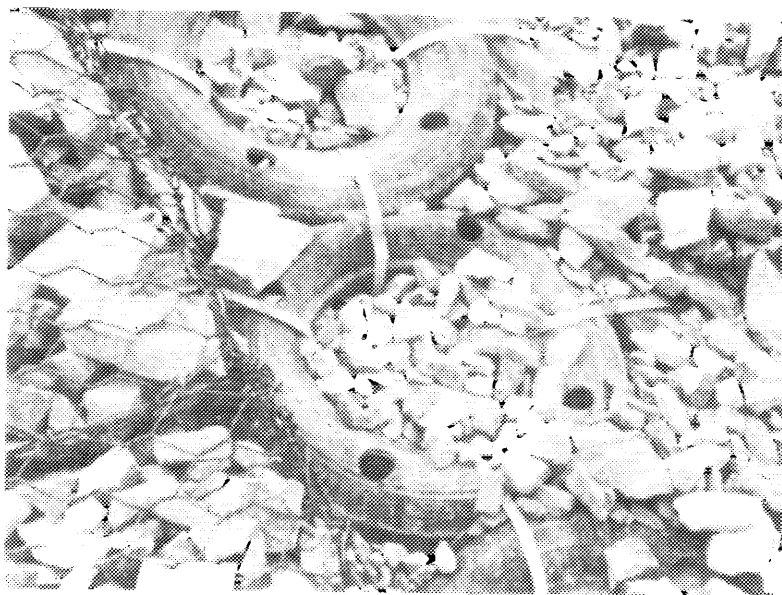
PHOTO 3  
REACH 1  
JULY 1979

a. Reach 1. Gabions, 3 feet wide by 12 feet in length were wire laced together and anchored to the slope in order to form a twelve-inch thick protective rock mattress. The mattress was constructed from an underwater dumped gravel toe on a 1.75H to 1V graded slope to a point 3 feet vertically above the normal water line. Filter fabric (Tygar Spunbonded Polypropylene, Style 3421) was used under the gabions along this reach. The bank above was dressed to its natural slope (1.5H to 1V) and seeded. See Photo 3.

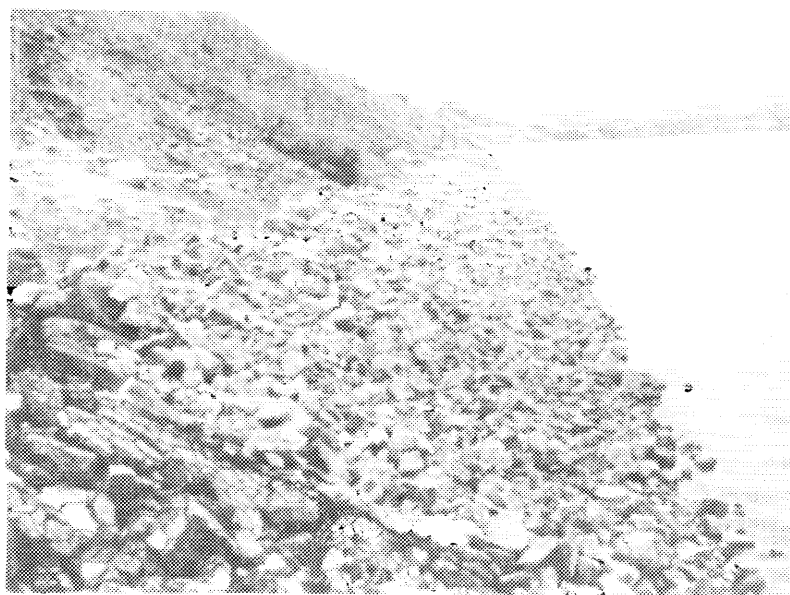
PHOTO 4  
REACH 2A  
JULY 1979

matting. Tires in the first half of the reach (2A) were filled with crushed stone while tires in the remainder of the reach (2B) were filled with random fill material. The bank above was dressed to its natural slope (1.25H to 1V) and vegetated. See Photos 4 and 5.

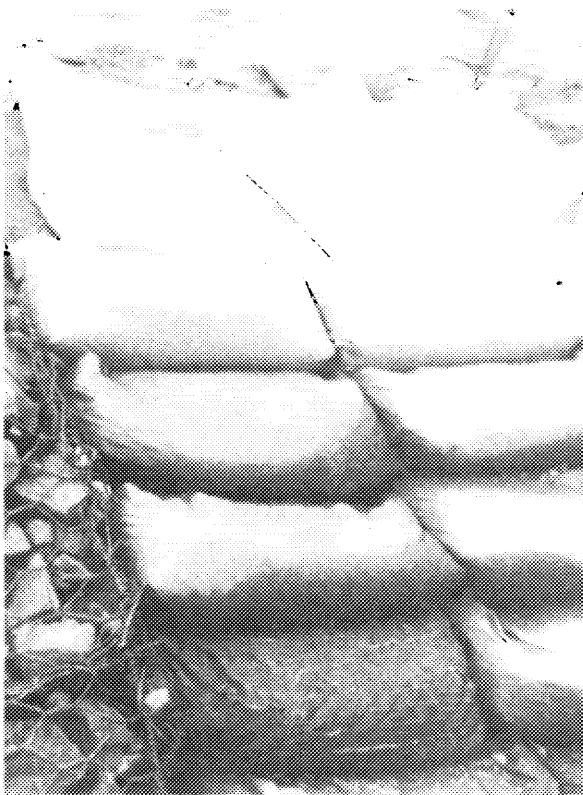
PHOTO 6  
REACH 3  
JULY 1979

c. Reach 3. Sand and cement filled reinforced paper riprap bags (Hudson's Reinforced Paper Riprap Bags) were placed against the bank on a 2H to 1V slope from the underwater toe up to a point 3 feet above the normal waterline. Filter fabric was placed under the sand and cement riprap bags along this reach. The upper bank was formed to a 2H to 1V slope and vegetated. See Photo 6.

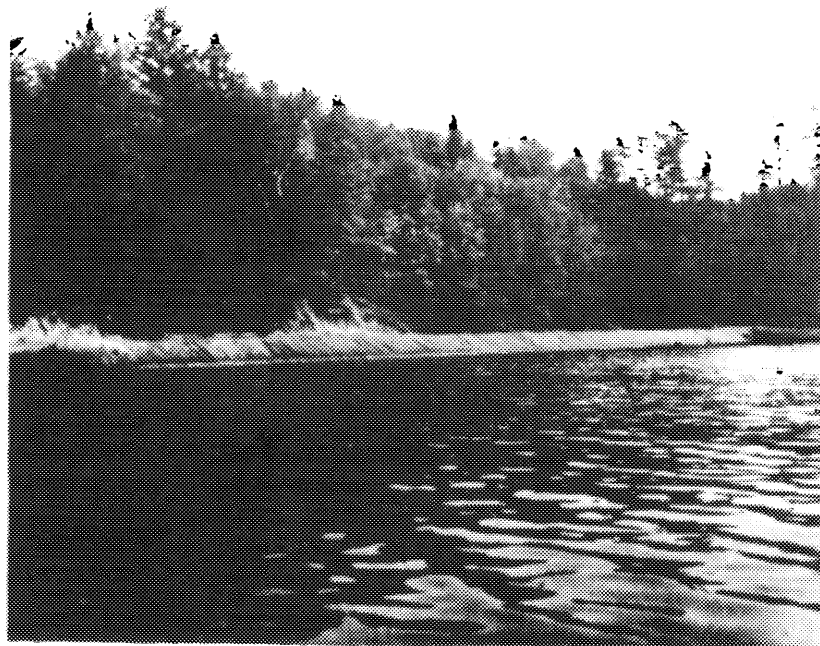
View of sand bedding material, Connecticut River at Hanover, N. H. The revetment work was built as part of the Wilder Dam reconstruction project. The normal high water is now within 1 ft of the top of the revetment (photograph furnished by New England Power Company, 1954)

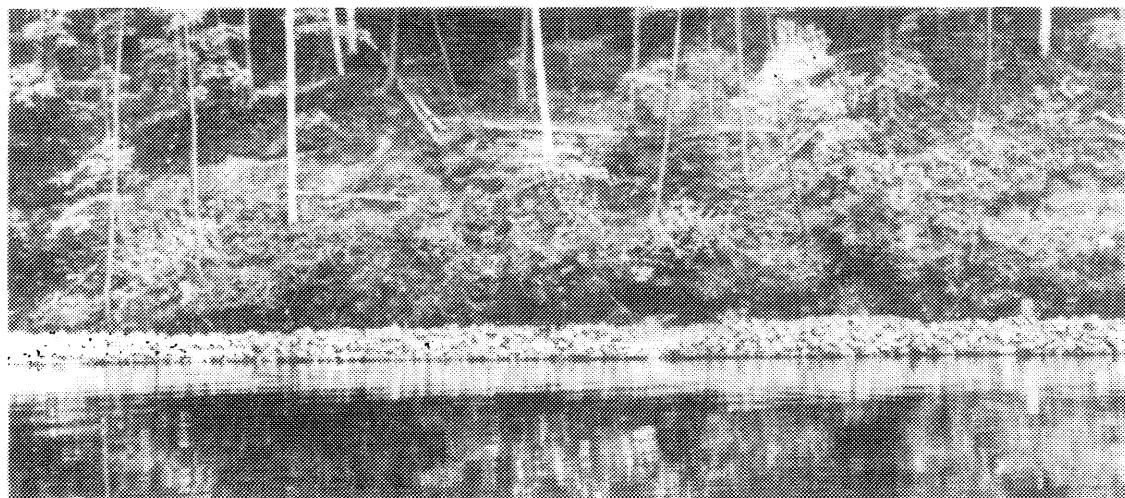
View of in-place riprap, Connecticut River at Hanover, N. H. The revetment work was built as part of the Wilder Dam reconstruction project. The normal high water is now within 1 ft of the top of the revetment. Streamflow is to the right. (Photograph furnished by New England Power Service Co., 1954)

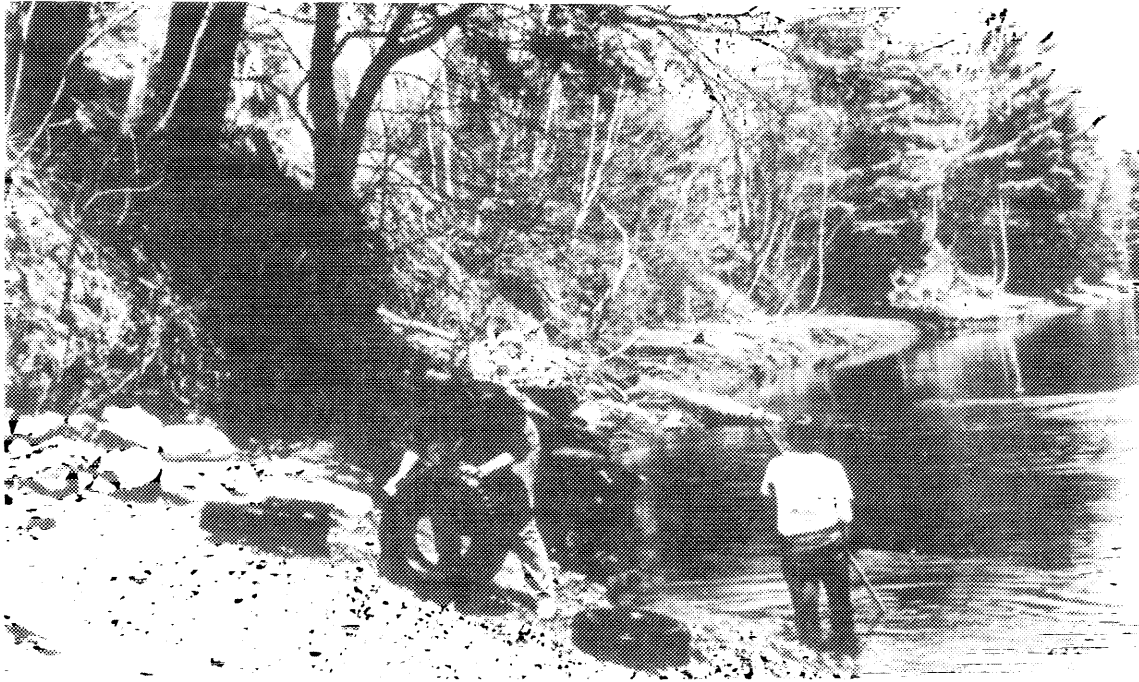
Initiation of used-automobile tire placement in the spring of 1972, Connecticut River at Thetford, Vt. Note eroded bank in background. The Allen residence is located approximately 50 ft landward from the top bank. View is upstream

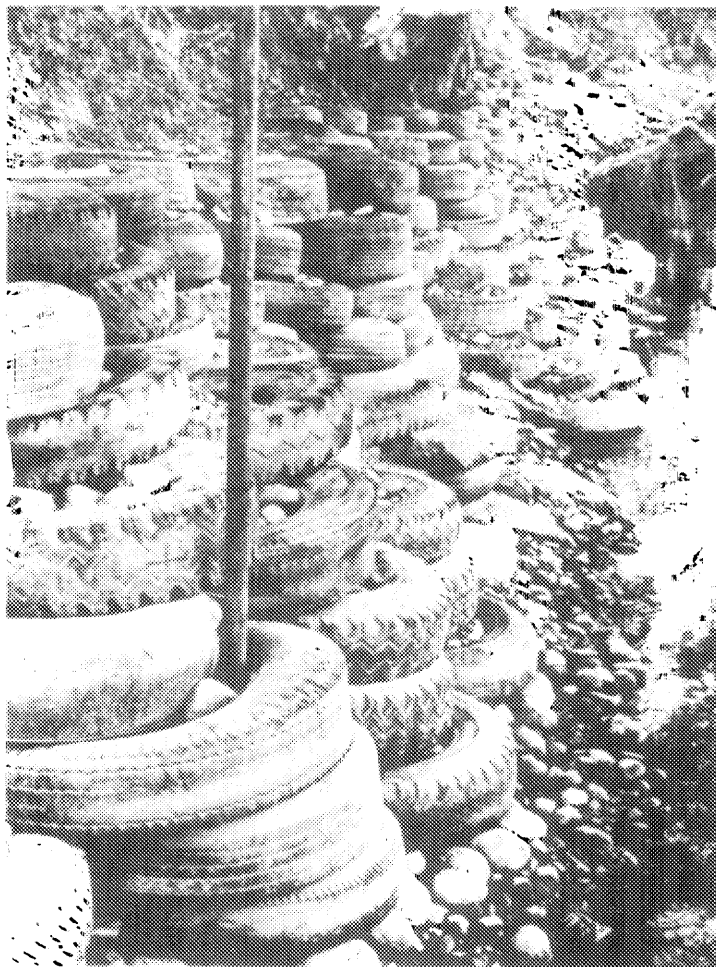
In summer 1972, private landowners constructed a 150-ft-long used-tire revetment on the right bank of the Connecticut River. Height of the protection ranged from three to fourteen layers of tires. Each tire was filled with small stones and tamped. At the time of the 1978 inspection, the revetment was intact, and a good stand of vegetation had become established on the upper bank. Minor structural damage was noted in a few places, including undercutting of tires at the upstream end of the revetment, which has resulted in the sagging of some tires and the spilling of fill material. There has also been some displacement of tires due to impact of ice cakes and heavy overbank drainage. Additional tires have been added to maintain the same top elevation. The New England Division, CE, has recommended that holes be drilled in the sidewalls to prevent flotation, that tires be tied together and anchored to the bank, that tires be stepped back 6 to 12 inches with each row, and that the space between the tires and bank be filled with earth or stone to prevent water or ice flow behind the structure.

Completed revetment shown at low water, Connecticut River at Thetford, Vt. View is upstream

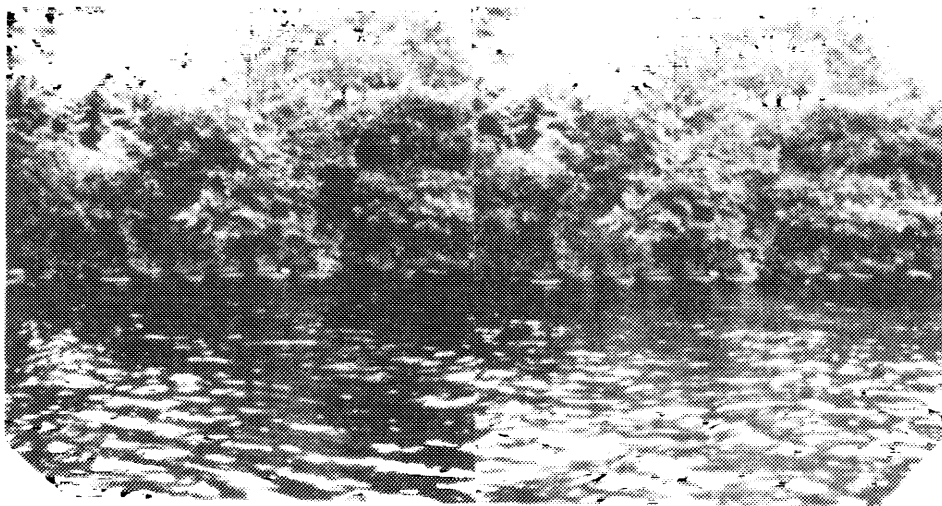
General Evaluation No signs of significant erosion were observed during visits  
Project in generally good condition.

Stereoscopic view of used automobile tire revetment taken during inspection visit, Connecticut River at Thetford, Vt. (26 July 1978)

Recommendations This form of revetment is ideal as a self-help measure  
which a landowner can undertake on his own.

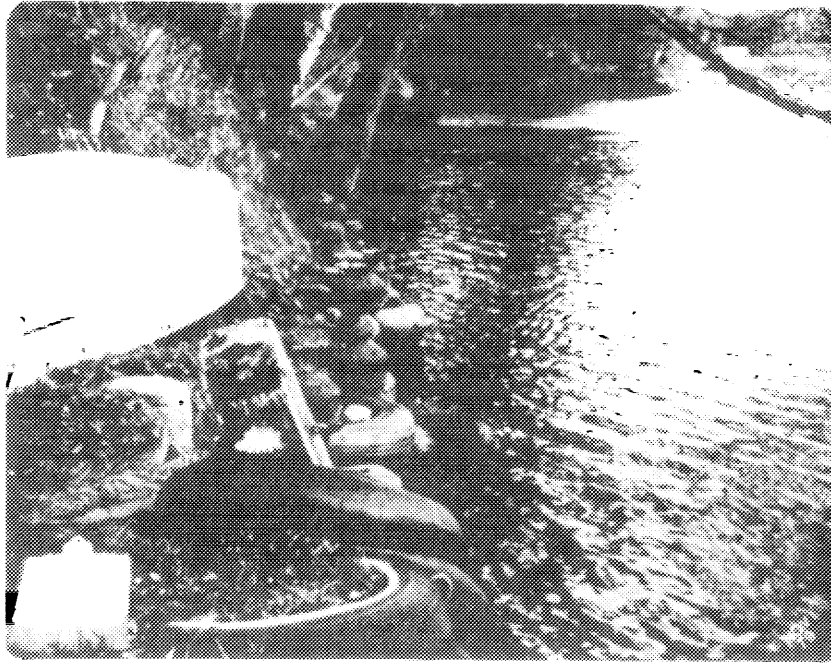
Upstream view of used automobile tire revetment of right bank of the Connecticut River at Thetford, VT. 1980

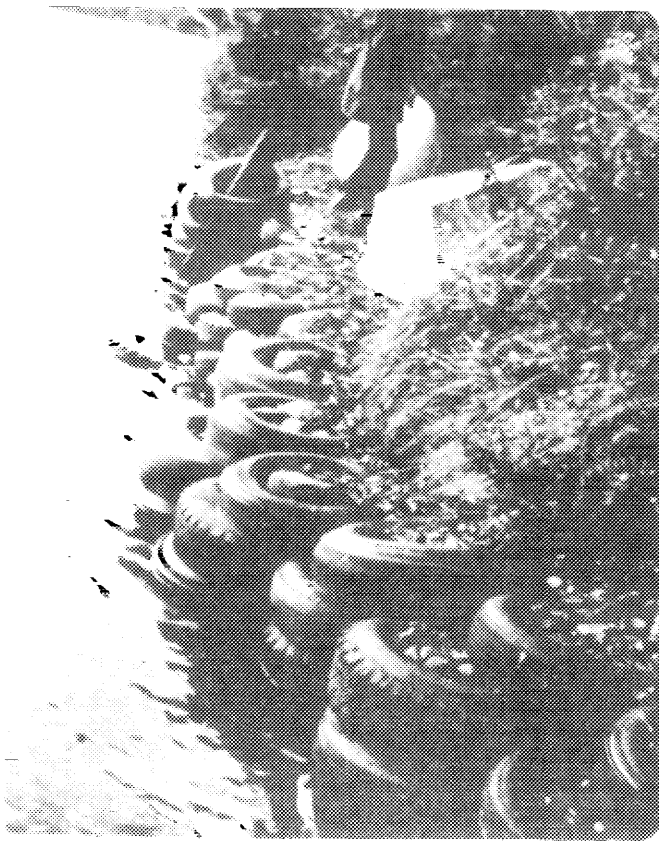
Downstream view of used automobile tire revetment on right bank of the Connecticut River at Thetford, VT. 1980

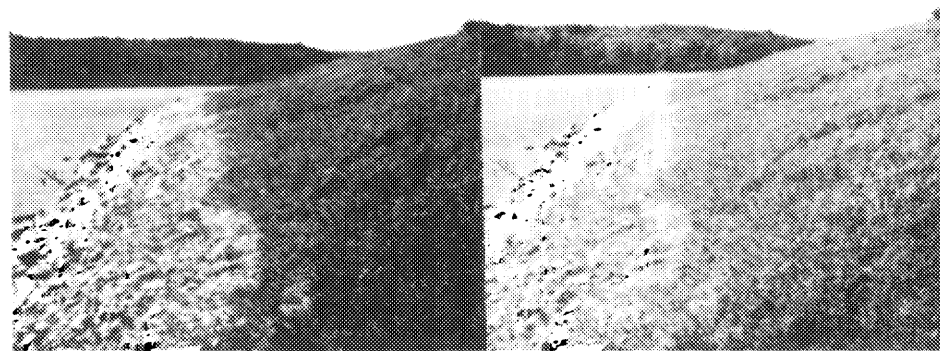
General Evaluation Areas involving tree removal and hydroseeding alone are in poor to fair condition. Riprap revetment was in good condition with no erosion.

Stereoscopic view of hydroseeded bank with riprap toe protection at Stacy's Ferry, Connecticut River at Turner's Falls Pool. The height from the water surface to the top of the revetment is approximately 4 ft, and to top bank, 12 ft. View is downstream (26 July 1978)

Recommendations Riprapped reaches working quite well. Hydroseeding of natural banks alone is only a marginal short-term solution.

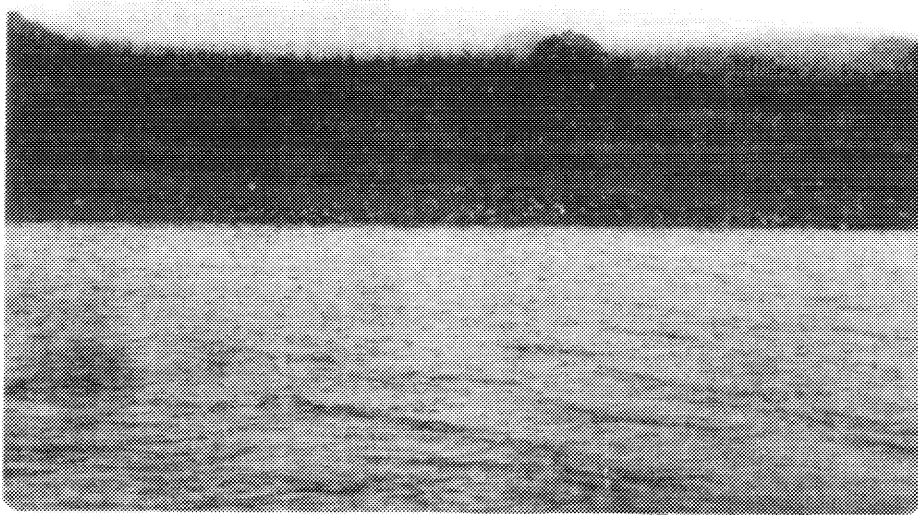
Vegetation had become well established at the Stacy's Ferry site by winter of 1977-78, Connecticut River at Turner's Falls Pool. The height from the water surface to the top of the revetment is approximately 4 ft, and to top bank, 12 ft (photograph courtesy of Northeast Utilities)

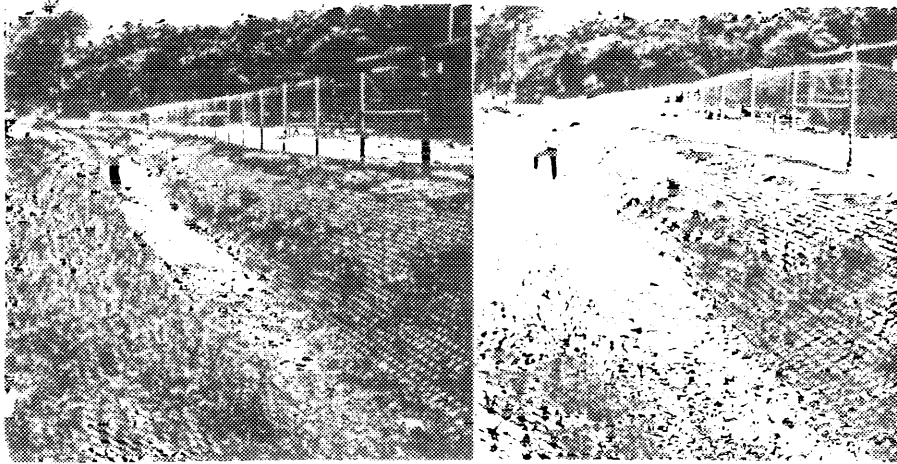
Successful Aspects Monoslab has successfully stabilized the streambank and has not required maintenance or repair since installation.

Upstream stereoscopic view of Monoslab revetment,  
showing trapezoidal channel cross section, Hayward  
Creek at Quincy, Massachusetts (25 July 1978)

Recommendations Due to lack of high flows, long-term stability unknown, so far, very effective in urban setting because it cannot be removed and thrown into channel as can riprap.

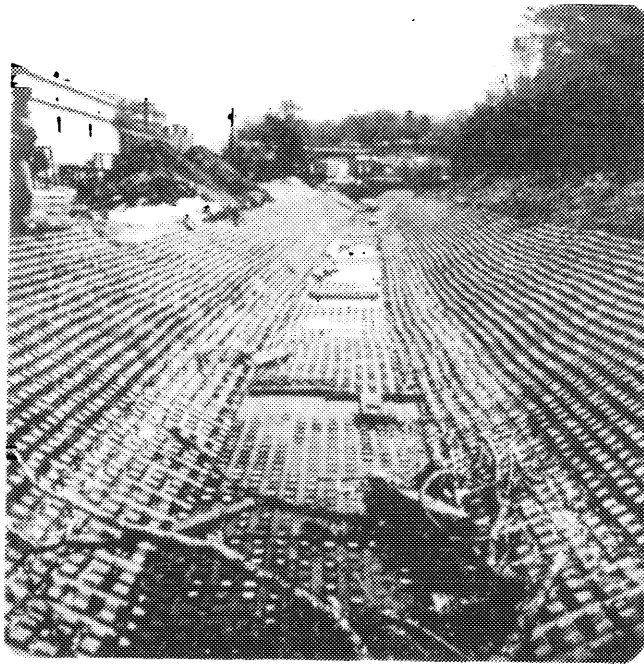
Looking downstream at Monoslab revetment,  
Hayward Creek at Quincy, Massachusetts  
(photograph furnished by New England  
Division, July 1978)

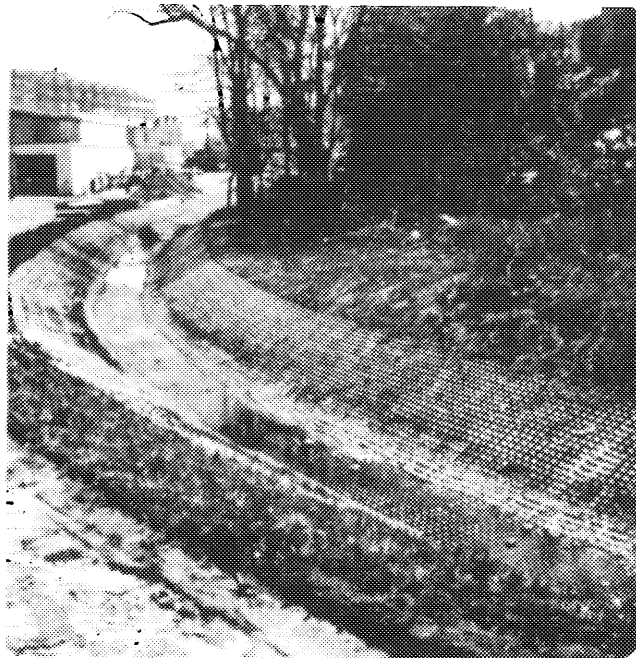
Upstream view of Monoslab revetment, showing  
trapezoidal channel cross section, Hayward  
Creek at Quincy, Massachusetts (25 July 1978)

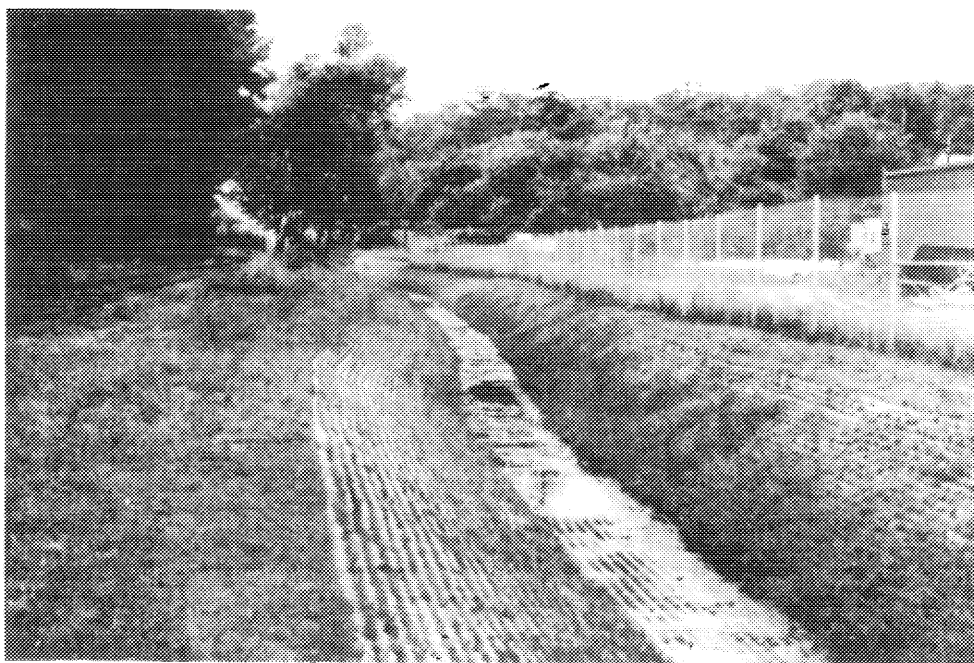
Looking upstream from Sta 1+25

Channel improvement for Hayward Creek consisted of a precast cellular block installation (completed in September 1977) to protect the banks and bottom from erosion. The blocks were placed over a sand layer and gravel bedding. Upper banks were seeded and mulched. In July 1979, minor settlement (about 1 in.) was detected on two areas of the bank; however, the settlement has not affected the integrity of the revetment. Grass growth is still sparse but it has been thus far proved adequate for erosion protection. New England Division, CE, has made the following recommendations regarding the use of precast cellular blocks:

- a. The blocks should be laid on a uniform slope.
- b. A base course, usually consisting of gravel, should be laid prior to block placement. A sand bedding should be used between the gravel and the blocks.
- c. The revetment should be extended past the top of the base.
- d. Provisions for the drainage of overland flow at the crest of the bank should be included in the project design, preferably an exposed open channel conduit running parallel to the channel alignment with provisions for discharge into the channel at periodic intervals.
